The Locomotive

THE HARTFORD STEAM BOILER INSPECTION AND INSURANCE CO.

VOL. XXXII.

HARTFORD, CONN.
1918-1919.

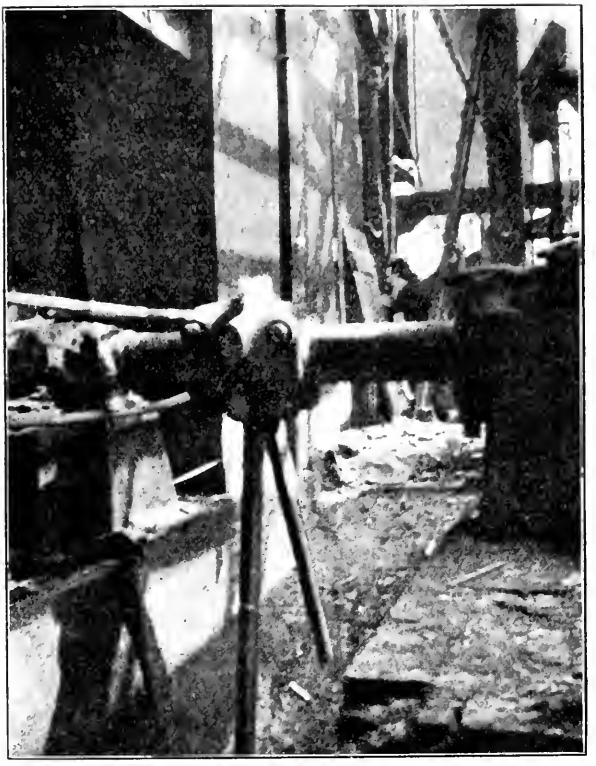
The Flywheel, After the Explosion.

governing mechanism was made, which discovered the fact that the governor stop of the engine was not of the automatic type, and that the safety cams were not adjusted to prevent the cylinder from obtaining steam when the governor was at its lowest point; on account of which the operation of the wheel was considered unsafe.

To return to the conditions discovered by our Inspector it will be remembered the safety cams were not in proper position and the governor stop did not operate automatically; so in case the governor stop was allowed to remain in shut-down position and the governor ceased to revolve for any reason, the cylinders would receive the maximum amount of steam and the governor would not act even if it descended to its lowest position as the safety cams were not properly adjusted.

However, upon receiving our report and recommendations the owner of the engine immediately made proper changes and improvements, so upon the re-examination the wheel was considered a desirable risk and a policy of insurance was written but only to be returned with the statement that the owner of the wheel did not then desire to insure it, feeling, no doubt, that as our recommendations had been complied with, the possibility of an accident had been eliminated and by carrying his own risk the premium would be saved; which, however, was not conclusive as later developments fully illustrated.

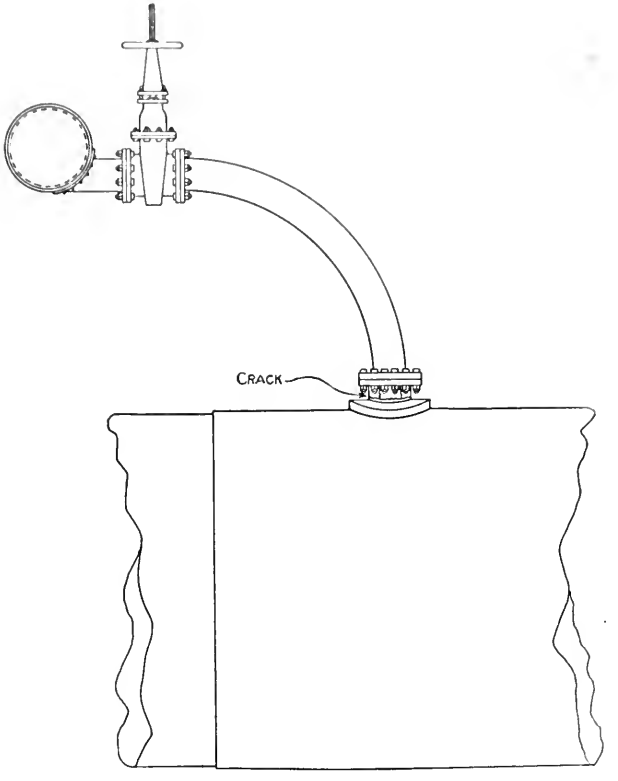
THE CRACKED NOZZLE WHICH THE INSPECTOR FOUND.

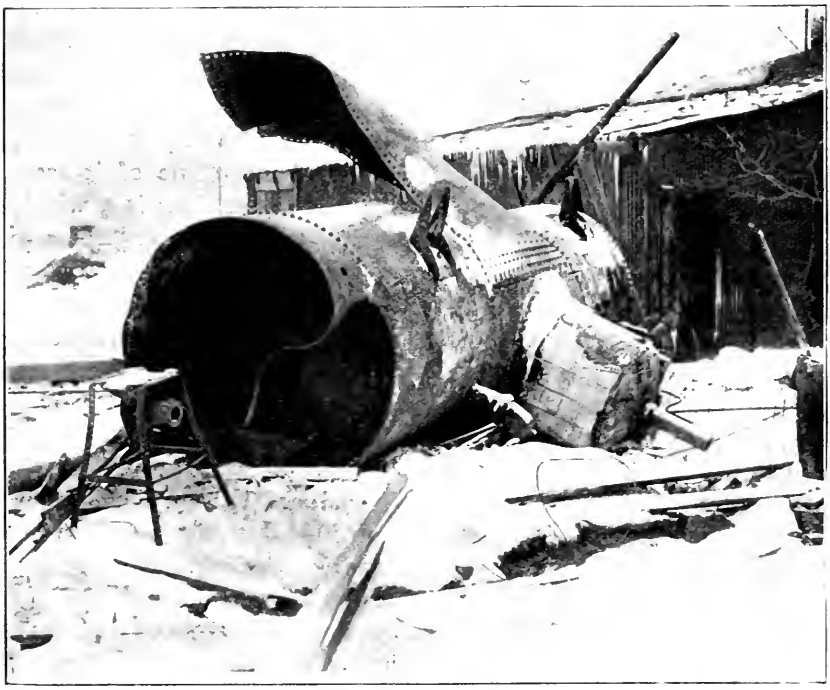
BOILER EXPLOSION AT THE SWANSEA, ILL. MUNICIPAL LIGHTING PLANT.

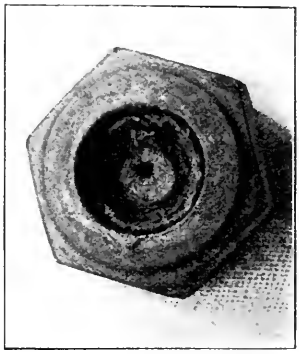
FIG. 1.

in his boiler by a false water registration in the gage glass. When the glass was removed from its fittings it was found that its lower or water end had at some past date caused inconvenience by leaking, and to stop this leakage a piece of rubber packing, circular in shape, had been inserted in the stuffing box, which had practically closed up the opening so that water could not rise in the glass to show the level in the boiler. That the attendant saw water in the glass before and after the accident we have not the slightest doubt, and the presence of the water can be accounted as due to the accumulation of condensation coming from the upper or steam connection. Fig. 1 shows the packing nut used on the lower fitting for compressing the packing around the glass so that it will be water tight, and you will note that the orifice is completely filled up with rubber, except for a small hole (less than 1/16 inch in diameter), in the middle. It is also to be noted that at the time of the accident, sediment which had settled in the bottom of the glass had closed off the opening to a still greater extent.

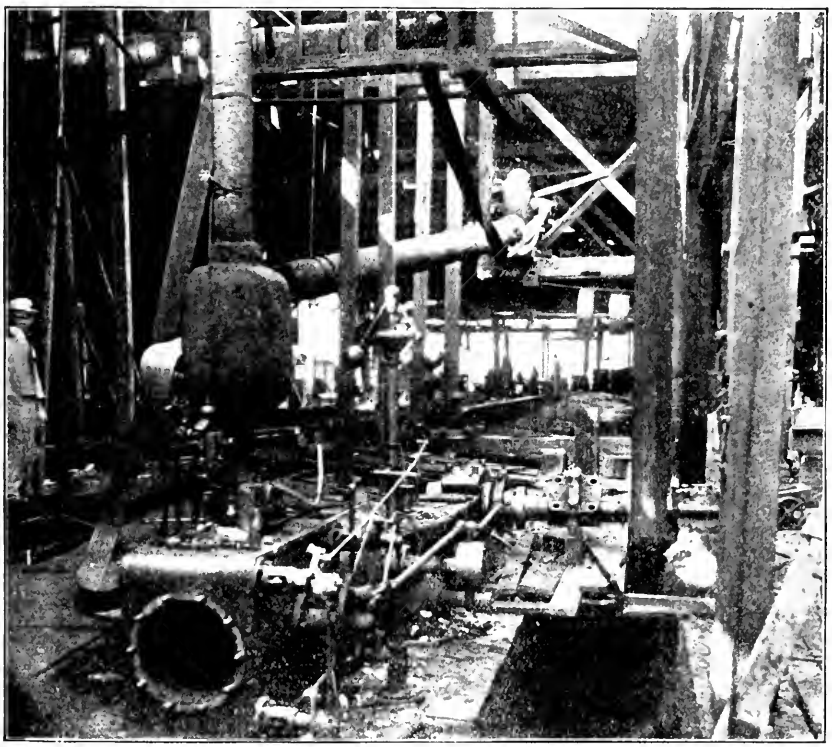
FLY WHEEL EXPLOSION AT HELENA, ALA.

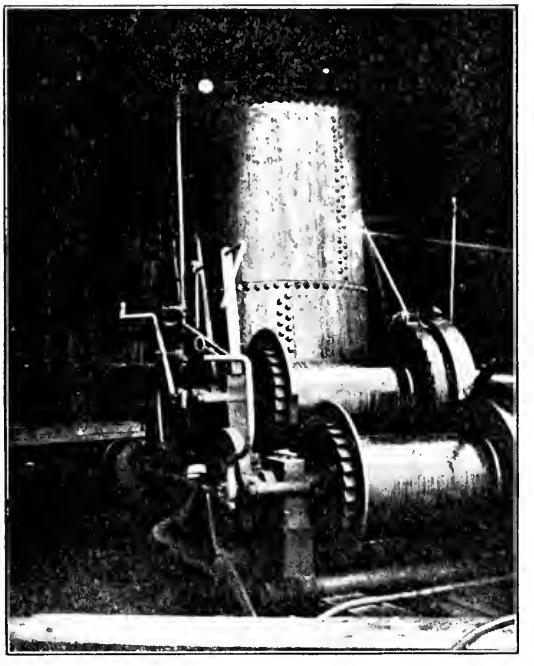
FIG. 1. WATER POURING FROM THE LAP CRACKED BOILER WHEN UNDER TEST.

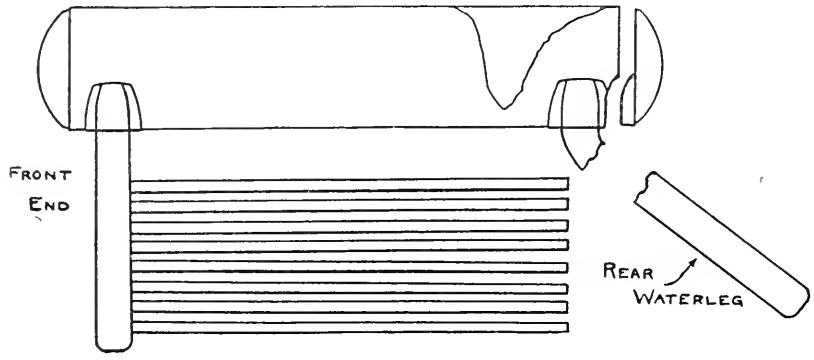
The Heine boiler, as far as the appearance of the parts shown after the explosion, seemed to be in good condition. The closed head on the mud drum of the Stirling boiler numbered 6, which was on the south side of this boiler next to number 5, was very seriously corroded; in fact, the lower half of the head on this boiler was reduced to approximately 3/16 inch in thickness. It appears that on this account the Government experts and others who examined the ruins decided that the Stirling boiler was the initial cause of the accident, and that the Heine boiler had exploded due to shock produced by the explosion of the Stirling. Notwithstanding this there are several reasons which seem to show that the

GENERAL METHOD OF FAILURE
OF THE NORTH BOILER OF THE
No 4 UNIT OF TWO HEINE BOILERS.

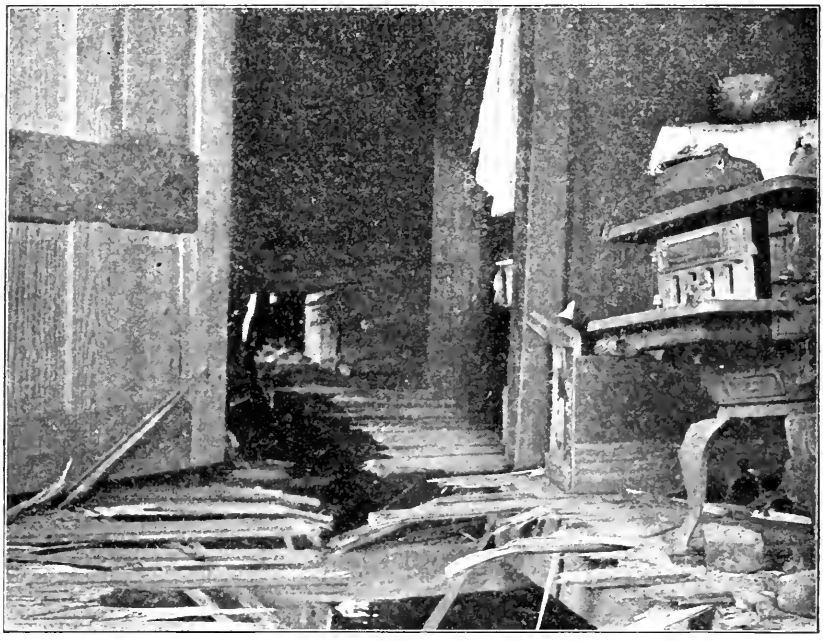
FLY-WHEEL EXPLOSION AT PASCAGOULA, MISS.

FIG. 2. THE DAMAGED DWELLING.

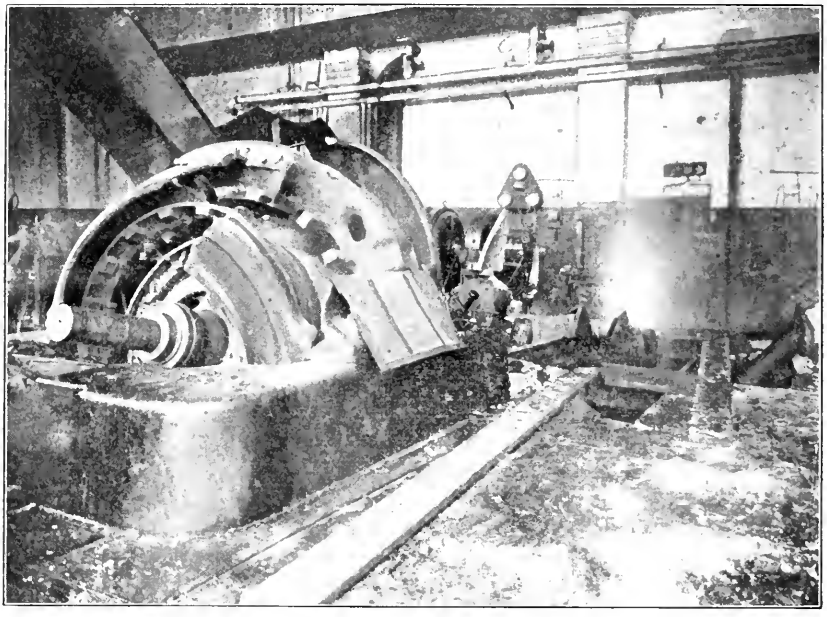
FIG. 1. VIEW OF GENERATOR

Explosion of a Large Steam Turbine.

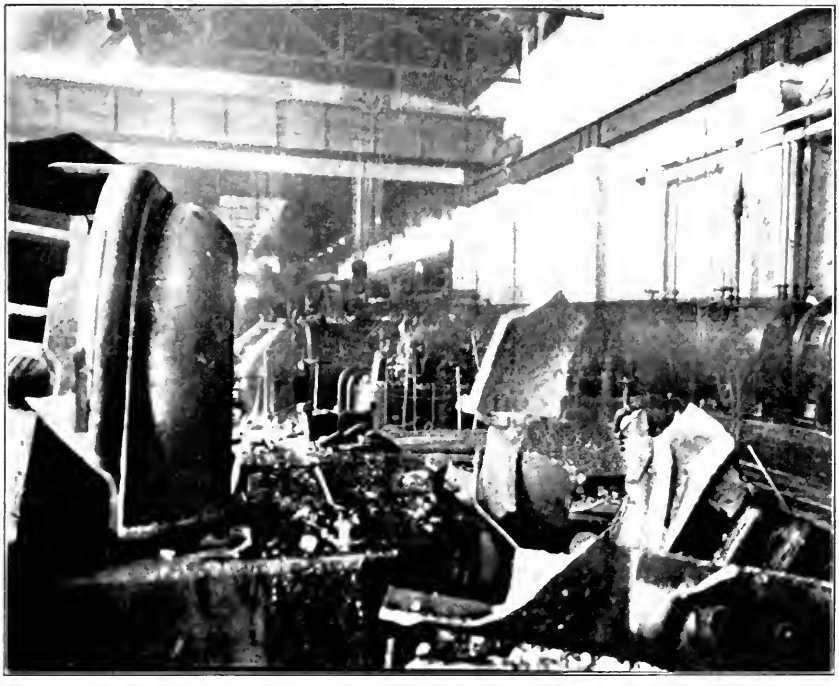
lights was caused by the loss of excitation on two and perhaps all of the four generating units and that thus these units were suddenly relieved of load. Two of the turbines, after the accident, were found with their automatic speed limits tripped and the steam shut off. It would appear from the report also that the investigator was satisfied that there was no material increase in speed of the wrecked turbine in the interval between the dimming of the lights and its destruction. The evidence to substantiate this negative conclusion was not given in the published report. It, however, must have been convincing to the

FIG. 2. TURBINE END OF WRECKED MACHINE

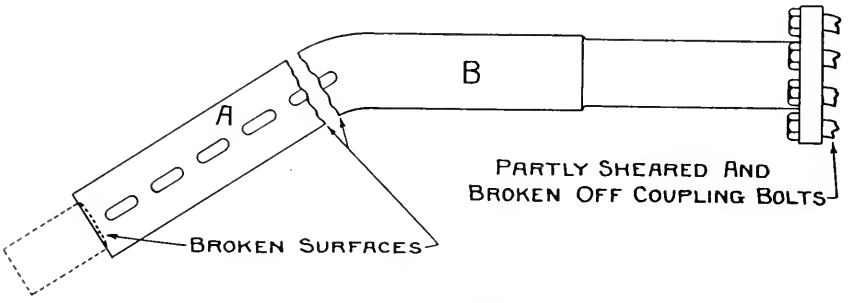
The wreck of the turbine itself was so complete and its remains consist in the main of such small fragments that from them it was impossible to determine at the examination made by a representative of our company what part failed first. The frame of the generator and its bearing pedestals were broken up and even the bed plate was

FIG. 3. SKETCH OF BROKEN TURBINE SHAFT

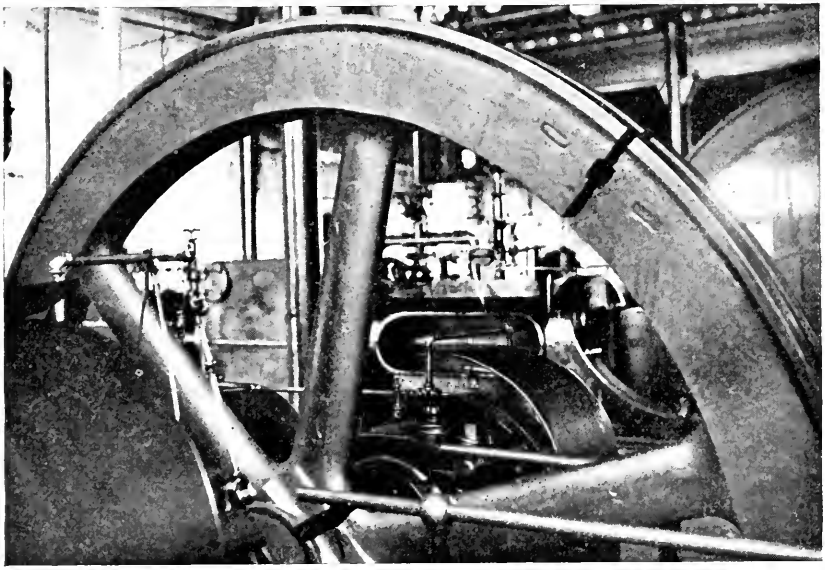
FIG. 1

An Unusual Flywheel Accident.

beyond some major fractures of the hub and arms of the wheel. The only usable picture we were able to secure of the wrecked flywheel does not clearly show that it was a complete loss. Such, however, was the case. The wheel in question was nine feet in diameter and was used in connection with a refrigerating engine. By the lucky coincidence that someone happened to be near the trottle and closed it at the moment the engine started to race, a complete disruption of the wheel was prevented. The wheel rim must have attained a considerable velocity as the links forming the rim-joints had stretched fully an inch due to the centrifugal force tending to separate the two halves of the wheel.

These links, which are round and of steel, are inside of the rim, a suitable recess being left in the rim to receive them, and they are secured to the rim sections by means of cotter keys. The only visible parts of the rim joint, therefore, after the wheel is assembled, are the ends of the cotter keys. They can be distinctly seen in the illustration, as can also the separation of the rim at the joint due to the stretch of the links.

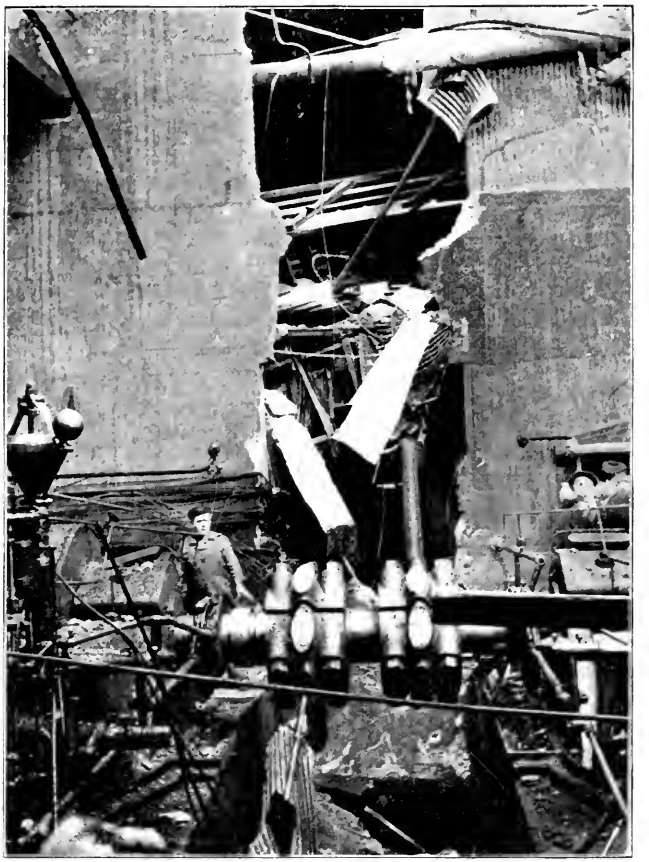
Flywheel Explosion at Scotia, Cal.

The leading cause of the accident was a sudden release of all load from the engine by the breaking of the main driving belt which is thought to have been brought about by a piece of wood wedging between the belt and the face of the wheel. The broken main belt knocked off the governor-driving belt from its pulley so that the governor stopped revolving. If the trouble had terminated there the dire results shown in the illustrations should have been averted by the so-called safety cams on the valve gear which come into play when the governor drops to its lowest position and prevent the further admission of steam to the cylinders. However, as the big belt coiled up into the wheel pit, it broke the afore-mentioned governor rockershaft, which

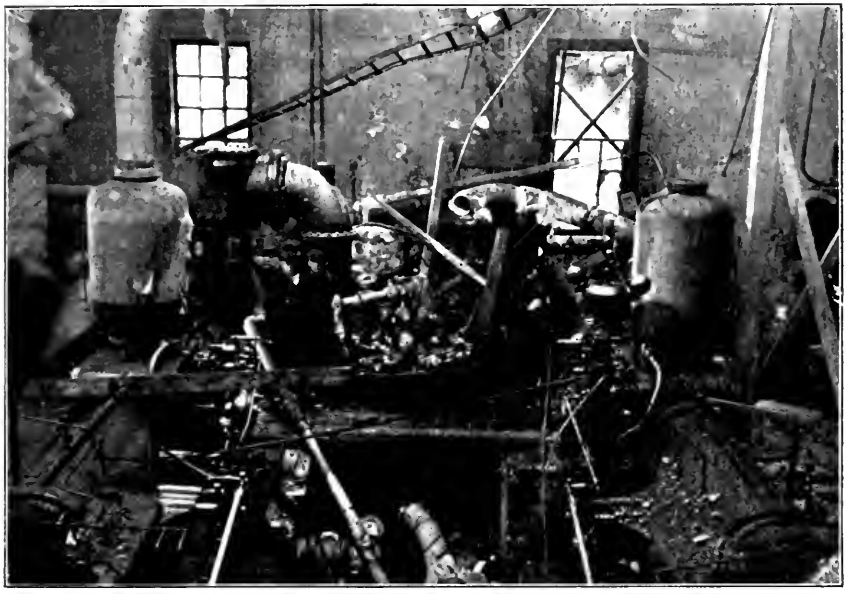
General View of Cylinders and Valve-gear.

The wheel was of the flange joint type, made in four sections and really consisted of two wheels bolted together which formed a total rim face of 5 feet. The engine on which the exploded wheel was mounted was of the twin type with releasing type of valve gears, both cylinders receiving steam at approximately boiler pressure. One fly-ball governor regulated the cut-off for both cylinders with the usual arrangement of a rockershaft extending from one side of the engine to the other and this feature appears to have had a more or less prominent part in the cause of the engine running away.

had the effect of preventing the safety cams on the north cylinder from functioning so that this cylinder continued to receive steam during a portion of each stroke and the speed of the engine increased rapidly.

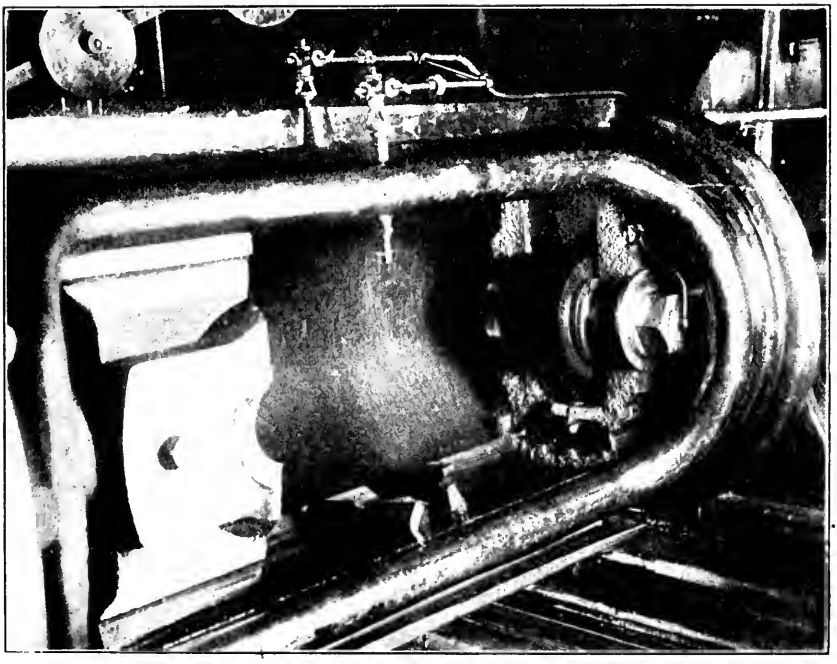
Broken Crosshead on Ammonia Compressor.

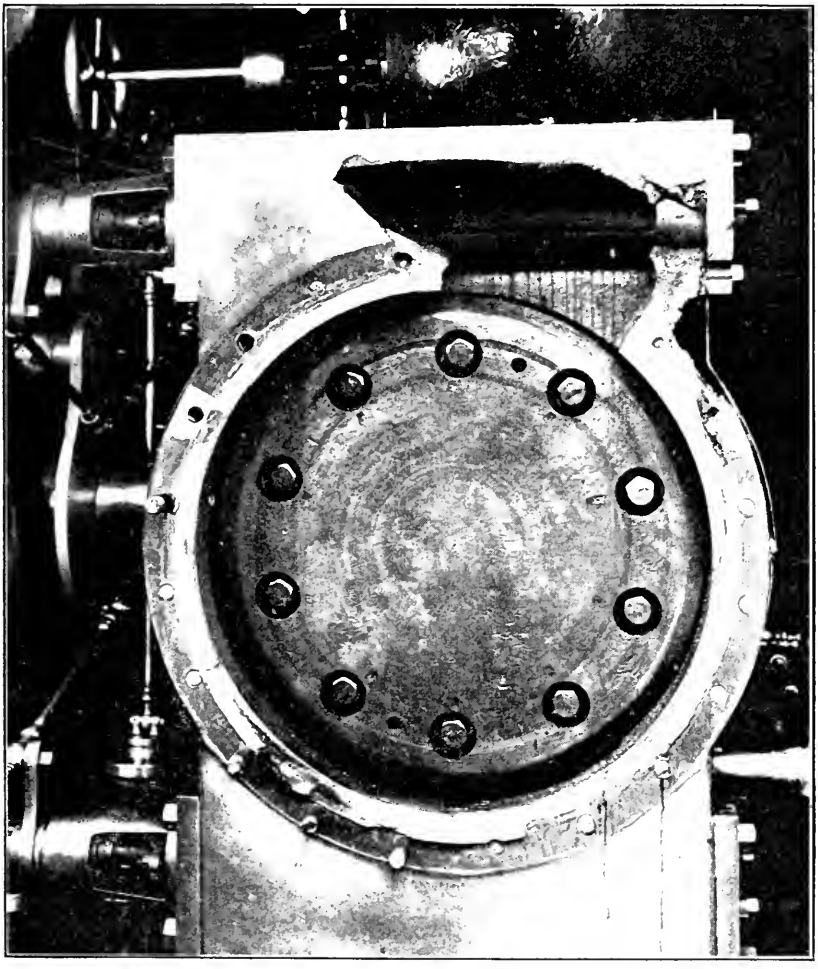
the cross-head attached to it had carried the rod into the piston which caused the collar of metal to be rolled up. The force of these two actions, however, was not sufficient to bring the moving mass to rest so that, after the cylinder head blew out, the parts continued their

View of Head End of Cylinder.

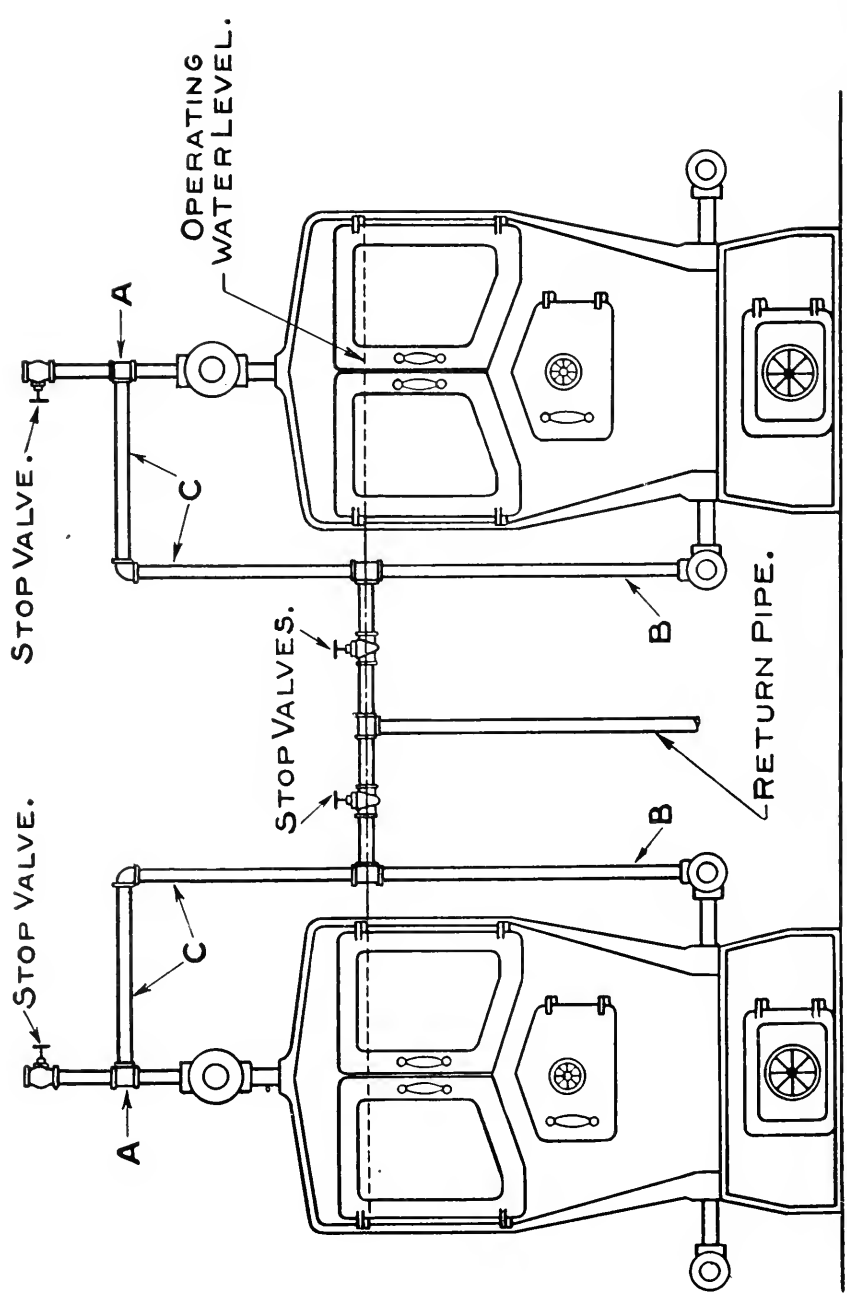
FIG. 2.

We now come to the main point of this article, the foregoing being all by way of introduction to a new scheme of attaching the return pipes to heating boilers as announced in the title. This new method of piping the returns is shown in fig. 2. It will be noted that no check-valves are used. The returning water from the heating system is carried to a point at about the water level of the boiler although it actually enters the boiler at the usual location at the bottom. It would, of course, be possible to carry the water into the boiler directly at about the water level, but this is not desirable with the average cast iron heating boiler, for the reason that it may cause too great a temperature difference at this level in view of the fact that the returning water can be quite cold.

However, with the arrangement as shown, it becomes necessary to install a steam equalizing pipe (marked " c " in fig. 2.) to the highest part of the return pipe, and this equalizing pipe must be of ample size

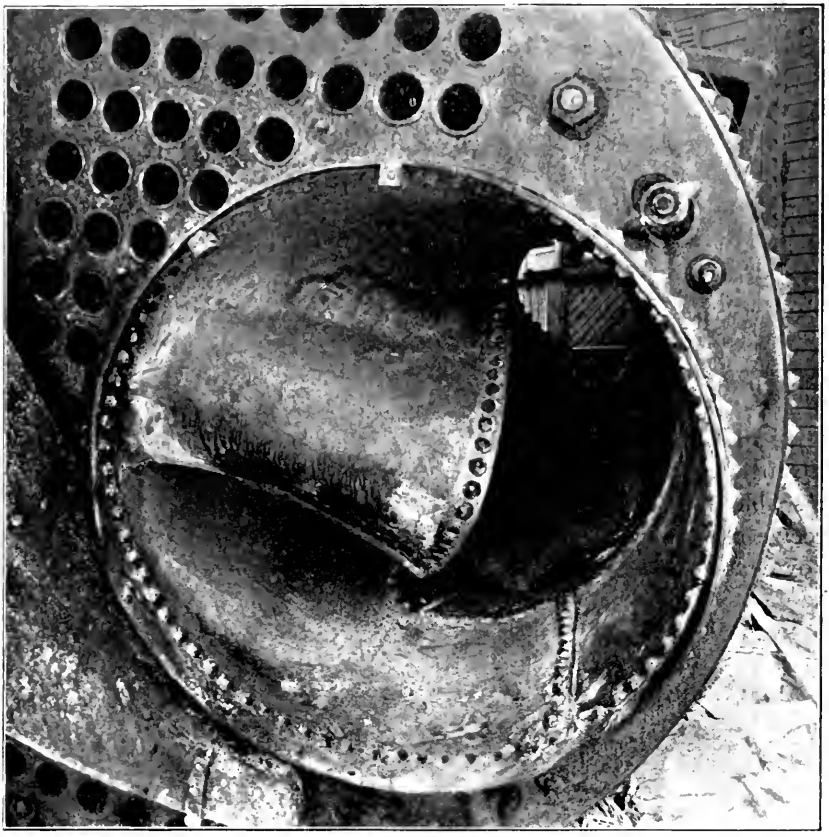
from head to head. The rupture, which started from the center on top and continued to a point about four inches below the horizontal center line on each side, was partly by tearing of the plate and partly by shearing of the rivets. Only one joint of the furnace was affected

View of Collapsed Furnace.

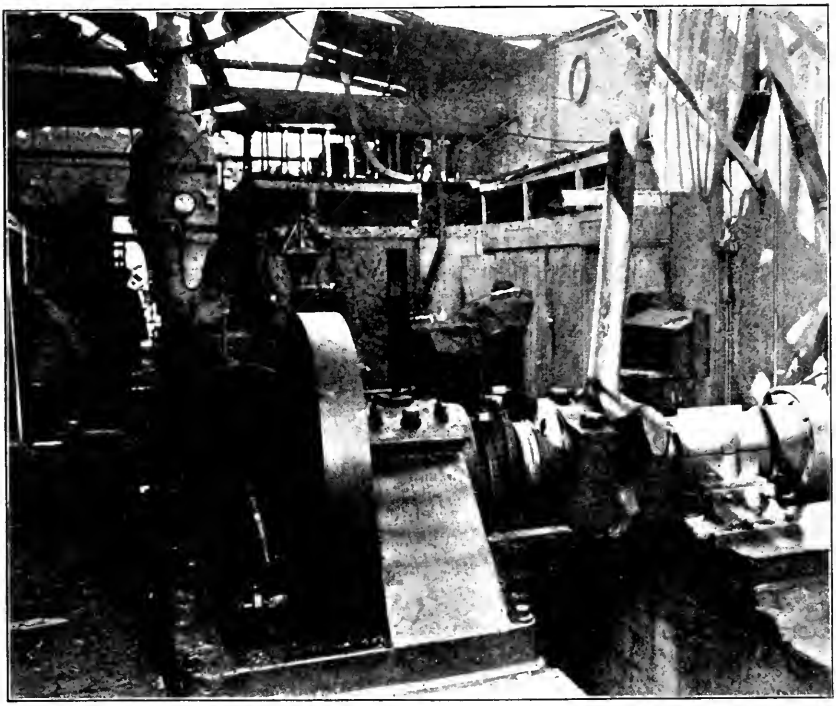
Flywheel Explosion at Stuttgart, Arkansas.

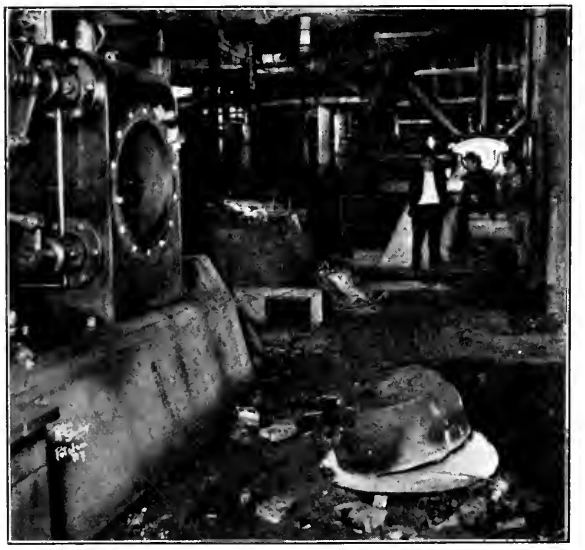
THE CYLINDER HEAD END OF THE WRECK.

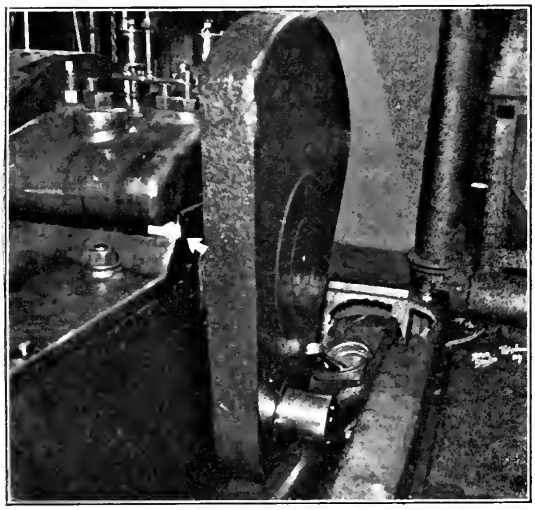
THE CRANK END OF THE WRECK.

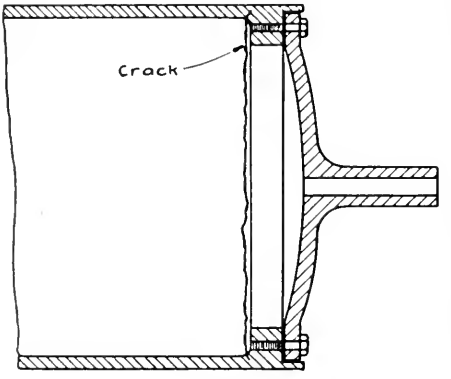
FIG. 1.

It was said that a few days prior to the explosion steam was seen escaping through a crack in the cast iron shell close to one of the heads of the mangle. To stop this leak, autogenous welding was resorted to and while this method of repair temporarily stopped

the escape of steam it would appear that it materially weakened the shell. Examination of the broken parts showed that the casting had been cracked for some time at the base of the flange, as shown in Fig. 1, this defect extending around the circumference meeting the welded portion at both ends, and varying in depth from one eighth to three eighths of an inch from the inside surface of the shell. The extent of this crack at the point where the leak developed could not be determined because the welding had destroyed all traces other than those mentioned above. The welded portion extended for about twenty-five inches around the circumference and was about five inches wide but its holding power was probably slight since a large portion of it appeared defective. At the break, the larger part of the weld had the appearance of slag which indicated that the metal had not fused at all, excepting on the outside surface. While no doubt the crack which already existed in the mangle cylinder would, in time, have caused a failure, it is, on the other hand, very likely that the welding hastened the end.

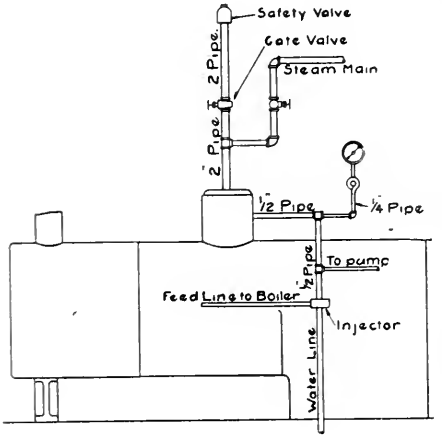
FIG. 2.

"The faulty connection that first struck my eye was that a ½" pipe had been run from the dome of the boiler to supply an injector and a feed pump, both of which required a 1" line, and to this pipe the steam pressure gauge had also been attached. The steam pressure, when first noted, was 100 pounds. Soon, however, the injector was started and, because of the pressure drop which then took place in the ½" pipe, the gauge reading fell back to 60 pounds. The engineer noticed this and immediately forced his fire a little harder which soon resulted in the safety valve blowing off although the gauge reading did not rise any great amount. Seeing this, the engineer remarked, 'Sometimes that safety valve doesn't work just right. I don't know what gets the matter with it. I've had it off several times and examined it but I can't find anything the matter with it.'

"I stepped outside to look up at the valve which was about twelve feet above the boiler and while looking at it the blowing stopped. A few minutes later I walked in and looked at the pressure gauge. It showed 140 pounds. I immediately started an investigation to determine the reason for the safety valve remaining closed with this pressure behind it and, when I climbed up on the boiler, I soon discovered the cause. There I found a gate valve, closed tight, in the line leading to the safety valve. Apparently the engineer had closed it when I stepped outside for just then I saw him come around to the front of the boiler, glance at the pressure gauge, and then rush up the ladder to open the gate valve. This I cautioned him to do slowly as a sudden release of the pressure on the boiler might have caused an explosion. As soon as a few turns had been given the gate valve to open it the safety valve began to blow and continued to do so until the pressure was reduced to 100 pounds.

"A sketch of the boiler with its improper pipe connections is given in Fig. 2. In addition to what is shown there I might mention that the blow off line had been piped outside the building where a trap had been formed so that any water accumulating in it would freeze very readily. A man, in blowing down the boiler, would have been placed in a very dangerous position.

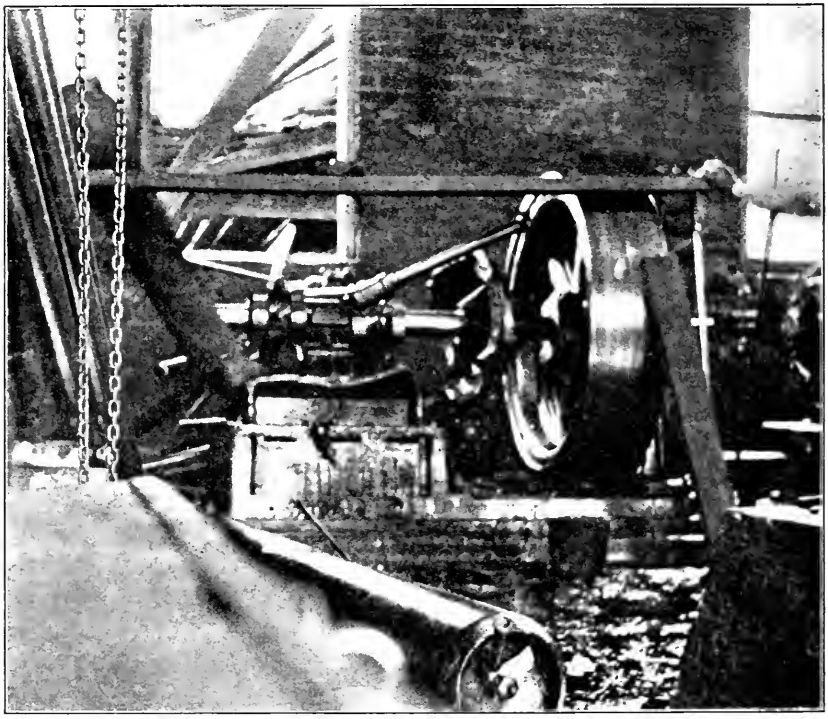
Wrecked Ammonia Compressor.

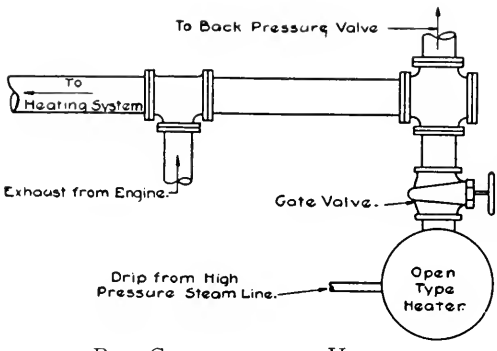
Pipe Connections to Heater.

WHEN is an "open heater" not an "open heater"? The recent explosion of a feed water heater of this type will serve to show that there is a possibility, through faulty pipe connections, for such equipment to become "closed" and capable of doing severe damage.

A plan of the arrangement of the heater and its piping is given in the accompanying sketch. The engine exhausted into a line which led, in the one direction, to the heating system and, in the other direction, to a back pressure valve and also to the heater, which could be cut off from the exhaust steam supply by a gate valve. The drips from a high pressure steam line were also led into the heater so that some of this heat could be returned to the boiler.

As the heater was in need of cleaning, the gate valve connecting it to the exhaust steam line was closed. The heater was not immediately opened, however, and as it apparently had no vent and leakage existed in the steam traps on the drips of the high pressure steam line, it was not long before a pressure was produced in the heater sufficient to burst it. A view of the wreck is given in the illustration herewith.

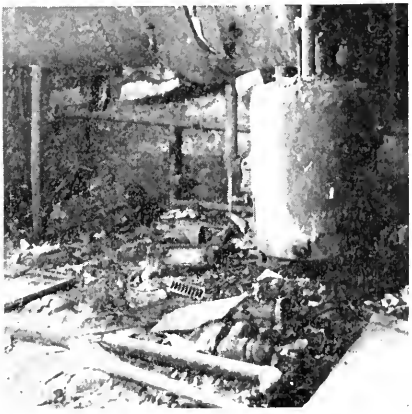
A boiler used for hot water supply exploded on March 18th, 1921 at the Hillcrest Apartments, 430 West 116th St., New York, N. Y. The boiler itself was demolished and considerable damage was done to the building. The boiler was one of a battery of two, both of which could be cut off from the water heating system by valves on the inlet and outlet pipes. It is thought that these two valves on the wrecked boiler had not been opened before placing the heater in service and that the safety valve had become inoperative, thus permitting an excessive pressure to build up and cause an explosion.
